# Klima in Museen und historischen Gebäuden: Die Temperierung Climate in Museums and Historical Buildings: Tempering

## Erfahrungen mit der Temperierung in Italien

### THE ITALIAN EXPERIENCE

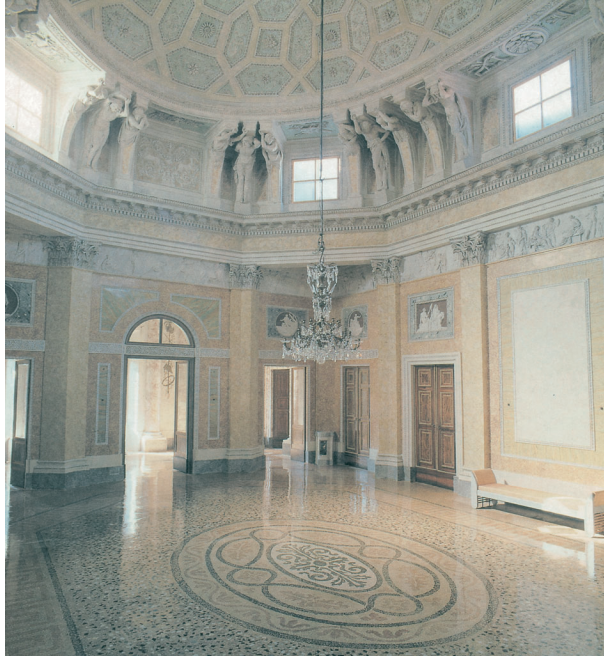
Abbildung 1:  
Ovaler Salon, nach Westen. Nur die Kuppel liegt im Außenbereich. Eine Ringleitung auf dem Architrav deckt ihren Wärmebedarf (s. Schnitt). Foto Alberto Grimoldi, Mailand.

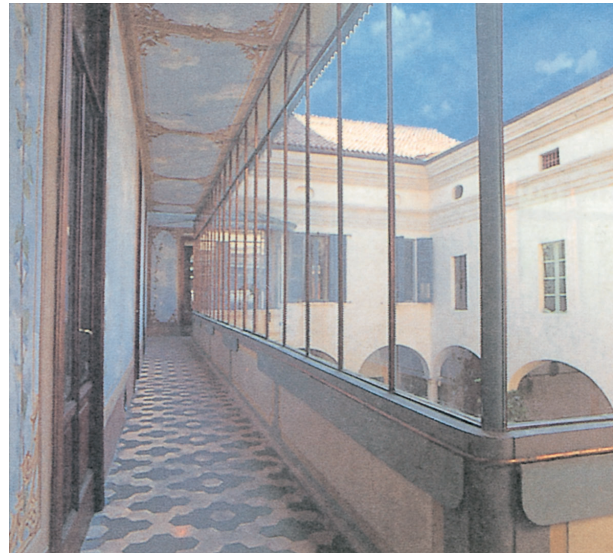
Abbildung 5:  
Loggia: Die Rohrschleife an den beiden Außenwänden des einfach verglasten Leichtbaus (Vorlauf im Mörtelprofil am Sockel, Rücklauf frei an der Brüstung geführt) genügt zur Temperierung dieses Durchgangsbe-  
reichs. Foto Alberto Grimoldi, Mailand.

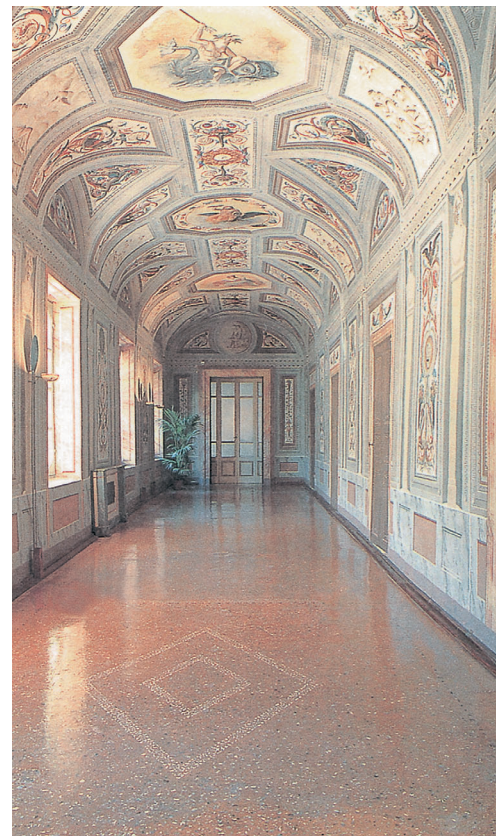
Abbildung 4:  
Pompejanische Galerie. Die haustechnischen Leitungen sind *auf* den Bauteilen montiert: Am Sockel der Außenwände unter einem Mörtelprofil die beiden Heizrohrschleifen, davor auf dem Boden unter einer hohlen Stuhlleiste die elektrischen Leitungen, die auch die vor der Wand montierten Standleuchten versorgen. Foto Alberto Grimoldi, Mailand.

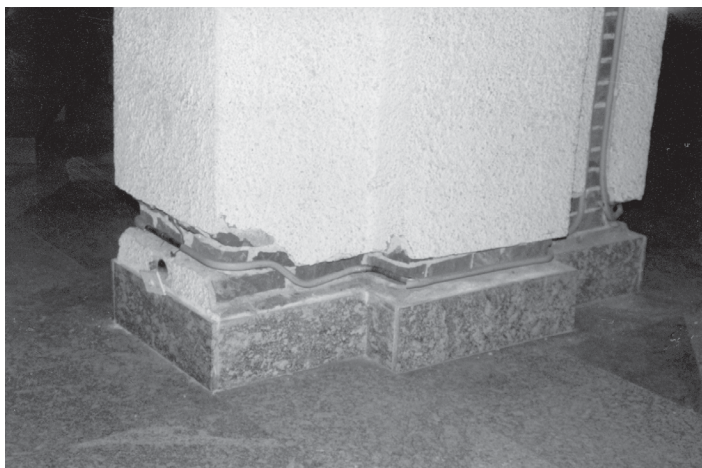
Abbildung 8a u. b:  
Kirche Sacro Cuore. Einbau der Temperierung. Der Putz mußte nicht erhalten werden.  
Fotos Autor.

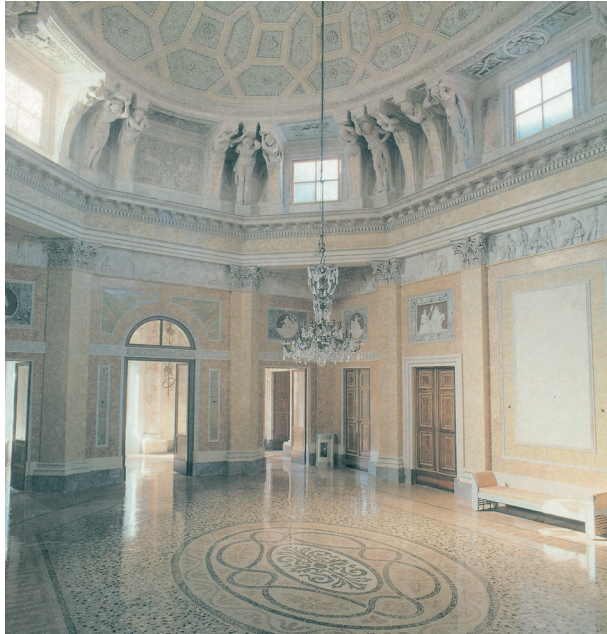
Fig. 1:  
Palazzo Cattaneo, Ala Ponzone. Oval Salon, looking west. Only the cupola is in the external area. A ring warm-water line on the architrave supplies its heating needs (see cross-section).  
Photo Alberto Grimoldi, Milan.

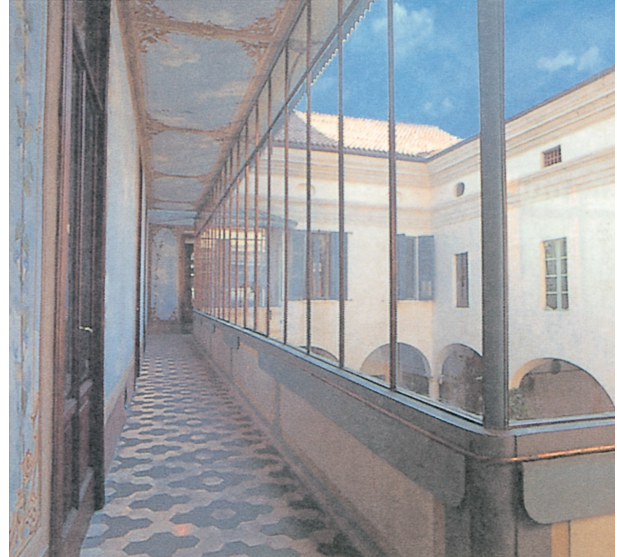
Fig 5:  
Palazzo Cattaneo, Ala Ponzone. Loggia: A pipe loop on the two outer walls of the thin-walled building part with single-pane glazing (foreline in layer of mortar at the wall base; return line mounted without a covering at the lower edge of the window-sills) is sufficient for tempering this area. Photo Alberto Grimoldi, Milan.

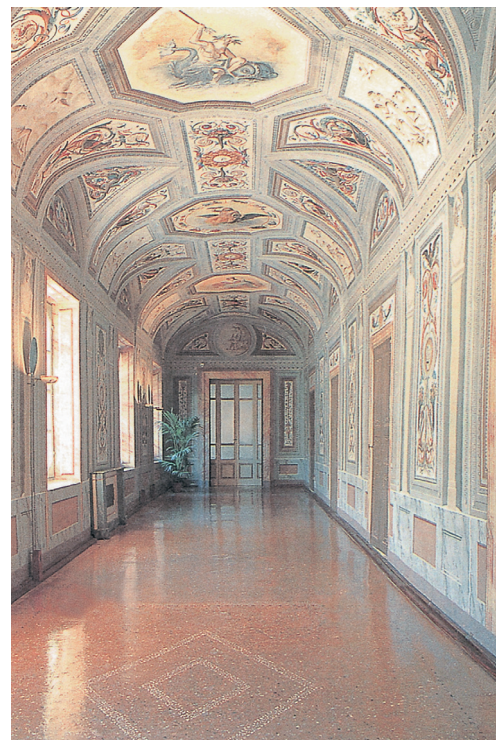
Fig. 4:  
Palazzo Cattaneo, Ala Ponzone. Pompeian Gallery. The water and electrical lines are mounted on the building elements: The two heating pipes are under a layer of mortar at the base of the outer walls. On the floor in front of these, underneath a hollow molding, are the electrical cables, which also supply the lighting fixtures mounted on the wall. Photo Alberto Grimoldi, Milan.

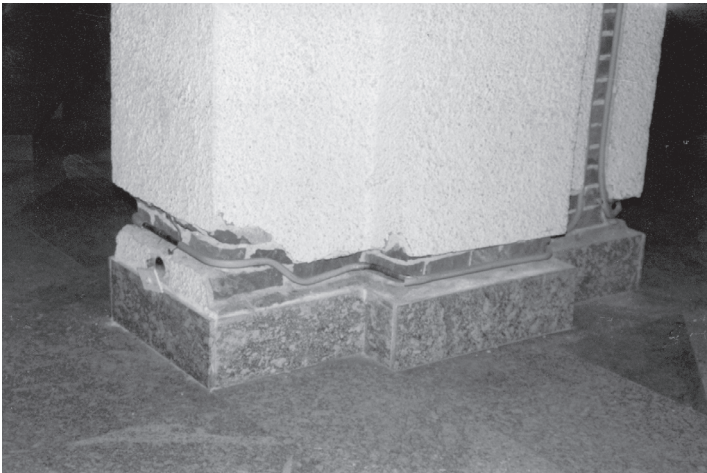
Fig 8a u. b:  
The Sacro Cuore Church. Installation of the tempering system. There was no need to preserve the original plaster. Photos Thomas Becker, Milan.
