Congreso Internacional
**EFICIENCIA ENERGÉTICA
Y EDIFICACIÓN HISTÓRICA**

International Conference
**ENERGY EFFICIENCY
IN HISTORIC BUILDINGS**

ACTAS | PROCEEDINGS

DESIGN OF A CONTROL SYSTEM FOR THE ENERGY CONSUMPTION IN A WALL-HEATED CHURCH: SANTA MARIA ODIGITRIA IN ROME

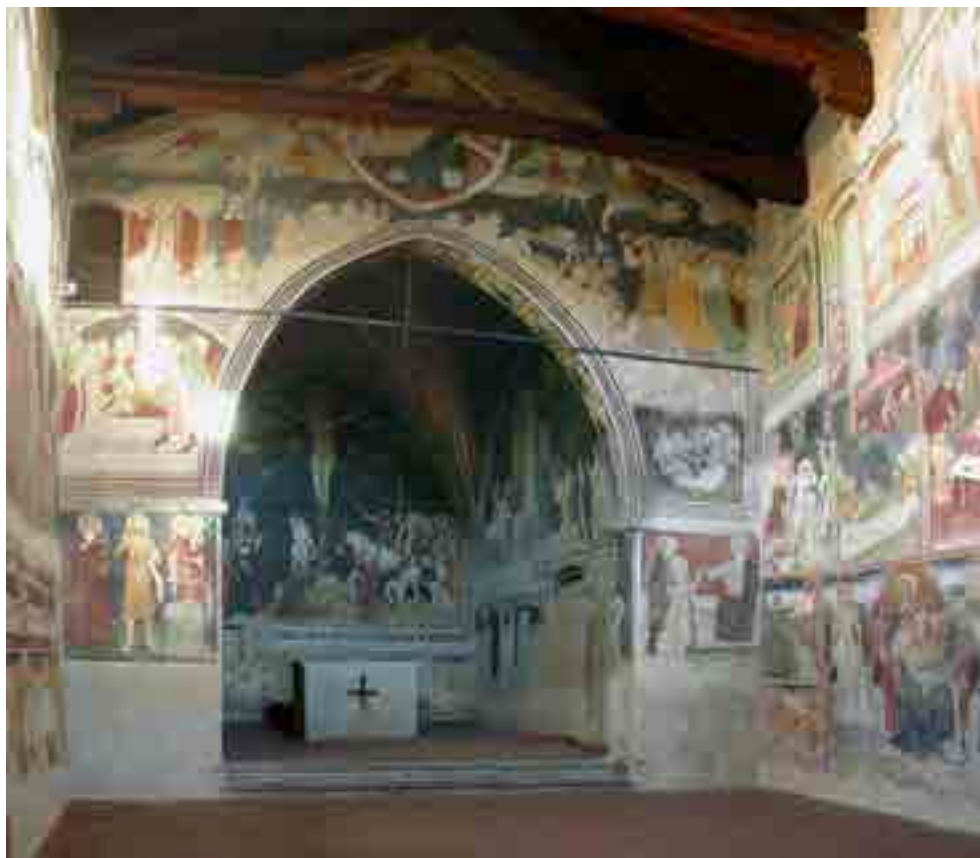
Image 1: Oratorio di Santo Stefano, Lentate sul Seveso (Milan). *Temperierung* runs under the plaster at the walls' foot

In 2007 a system was installed at the Oratorio di Santo Stefano in Lentate (fig. 1). In this case it consists in a simple copper ring circuit, placed at the foot of the wall, at the height of the plaster peeled off the wall due to the action of rising damp. The wall was plastered again, including (and hiding) the copper circuit sticking to the masonry, which makes the radiant effect more effective. It aims at avoiding that the most exposed part of the wall to the condensation could reach temperatures below the dew point. The system also allows a moderate warming, in order to keep acceptable the indoor climate for sporadic guided tours, lasting max one hour, as the present use of the building requires [12].

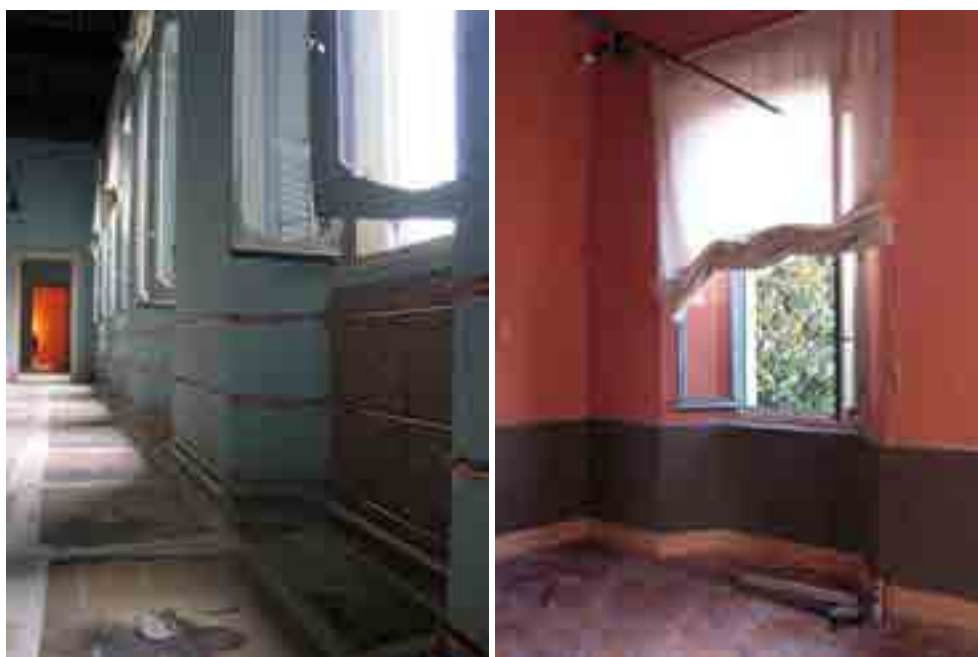
Image 2: Museo del Paesaggio, Palazzo Dugnani Viani, Pallaanza

In 2009 another *Temperierung* heating system was installed in Palazzo Viani Dugnani in Verbania-Pallanza (fig. 2), where the oldest Museum of the Landscape of Europe, founded in 1914, is housed. The building was built over different ages, but in its current appearance probably goes

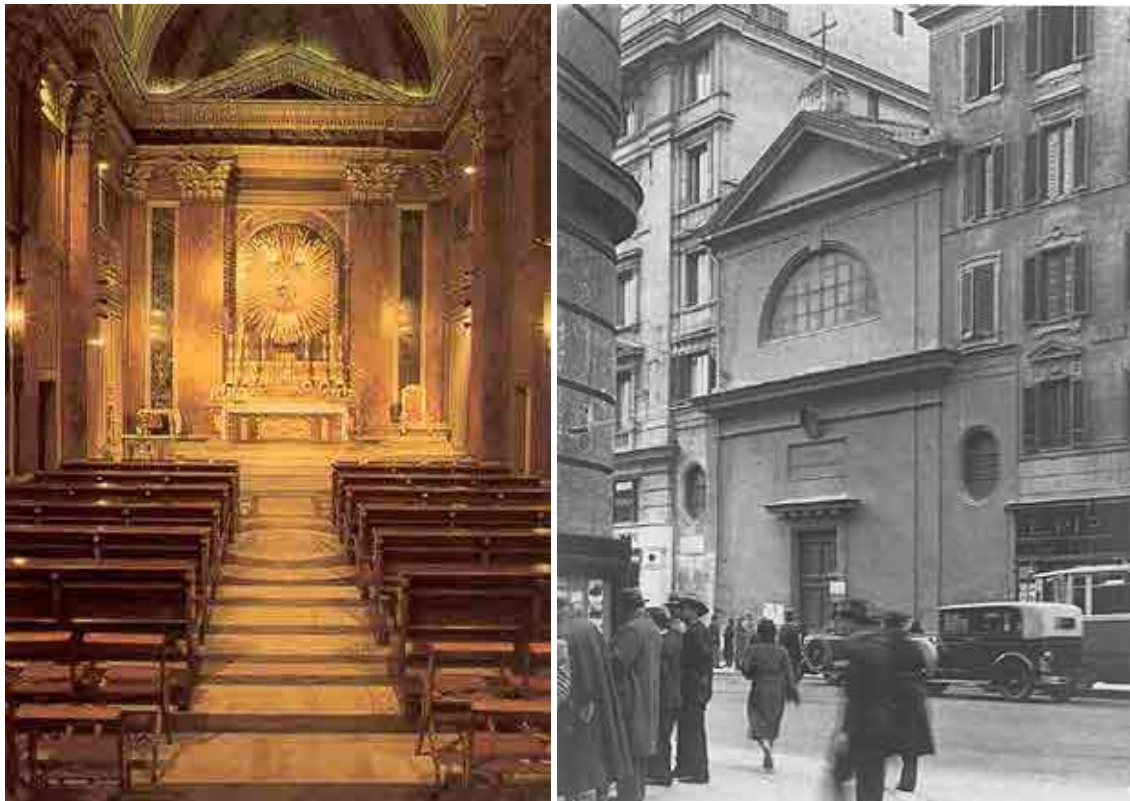
Image 3: Church of Santa Maria Odigitria, Rome (Courtesy by G. Pagliarulo, Rome)

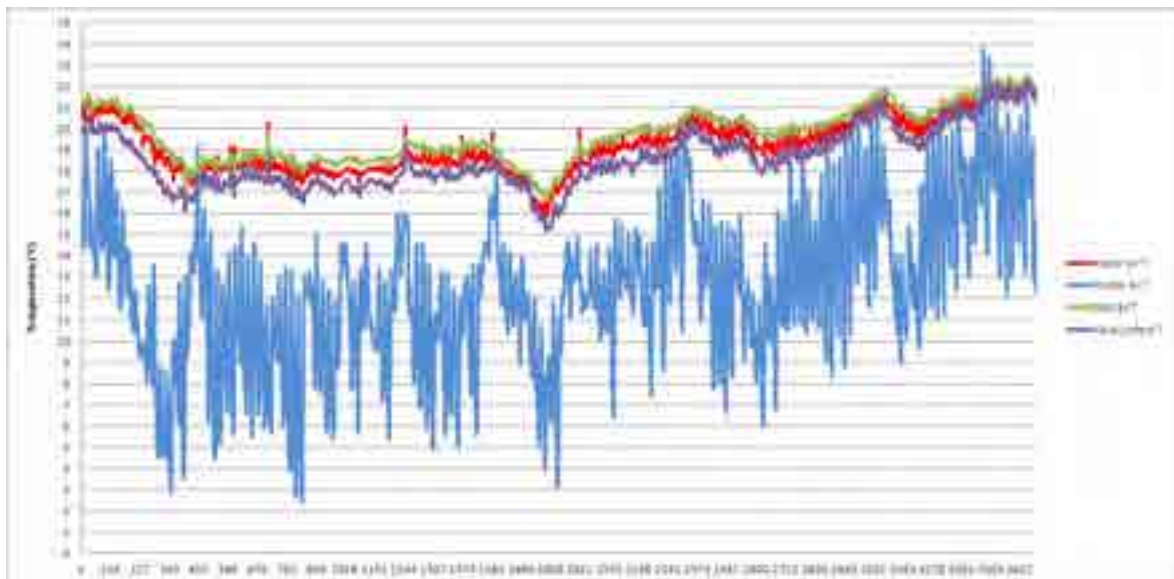
Image 7: S. Maria Odigitria. Monitored values (average temperature data): surfaces temperatures; indoor and outdoor air temperature from November 13, 2013, to April 15, 2014. From above: green: indoor air T; red: wall surface T; violet: barrel vault T; blue: outdoor T. © HypoThermos, Servizi Territorio srl.

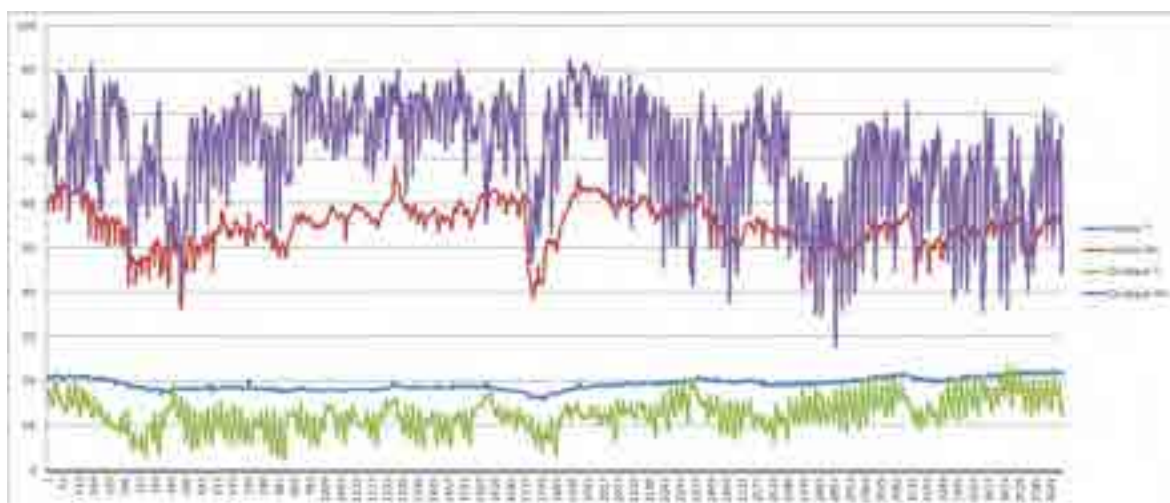
Image 9: S. Maria Odigitria. Comparison between RH and T values from October 23, 2013 to April 24, 2014. From above, violet: outdoor RH; red: indoor RH; blue: indoor T; green: outdoor T. © HypoThermos, Servizi Territorio srl.

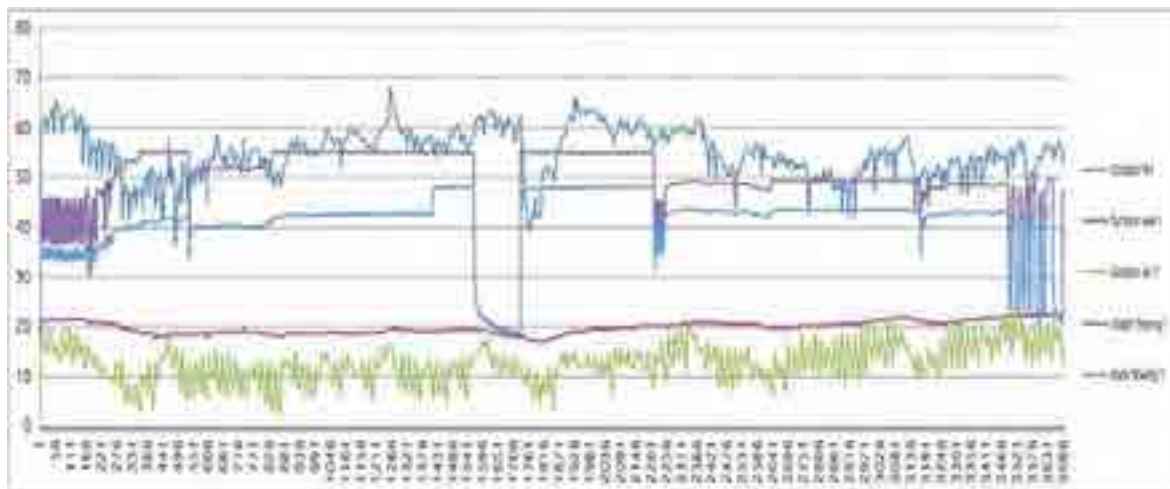
Image 10: S. Maria Odigitria. Comparison between indoor RH and T values, and water flowing T. Cyan: outdoor RH; violet: surface wall T; blue: back flowing T; red: indoor T; green: Outdoor T. © HypoThermos, Servizi Territorio srl.
